Malfunction crack failure in hydrodynamically lubricated bearings: A Case Study Hydraulic Turbine

Yahya Taşgın¹ and Gökhan Kahraman¹

¹Munzur Universitesi

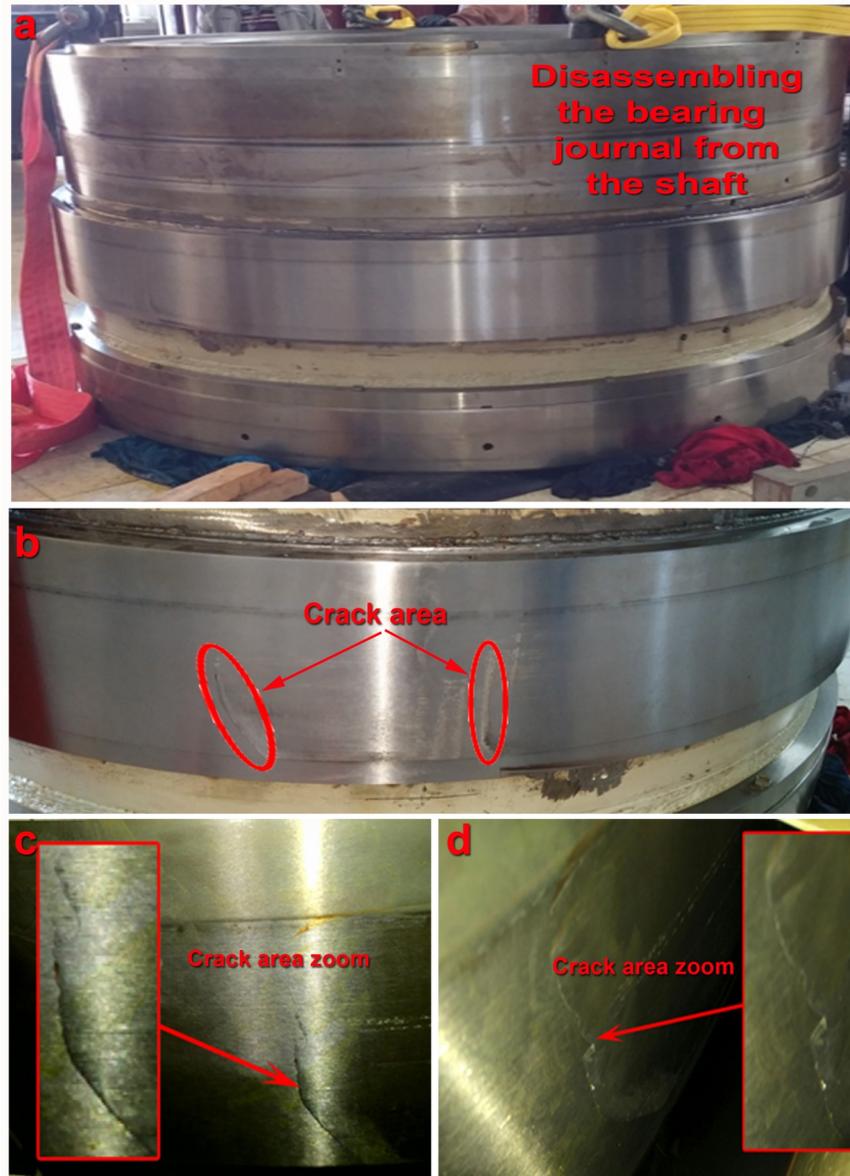
In the fractures in the sliding bearing shell, it disrupts the theory of hydrodynamic lubrication and causes the oil film to rupture. The bearing shell fracture in the generator guide bearing of a hydroelectric power

plant is shown in Figure 2

Figure 2. Image of crack areas on the bearing trunnion

As can be seen in Figure 2, the fracture in sliding bearing shell has reached the level to prevent the efficient operation of the bearing. In addition, the fracture seen in figure 2 continues to progress. Differences in the values of the vibration sensor connected to the turbine generator unit were interpreted and the generator guide bearing area was disassembled and fixed on the fracture bearing shell and the fault clearance studies were initiated without causing major damage to the bearing.

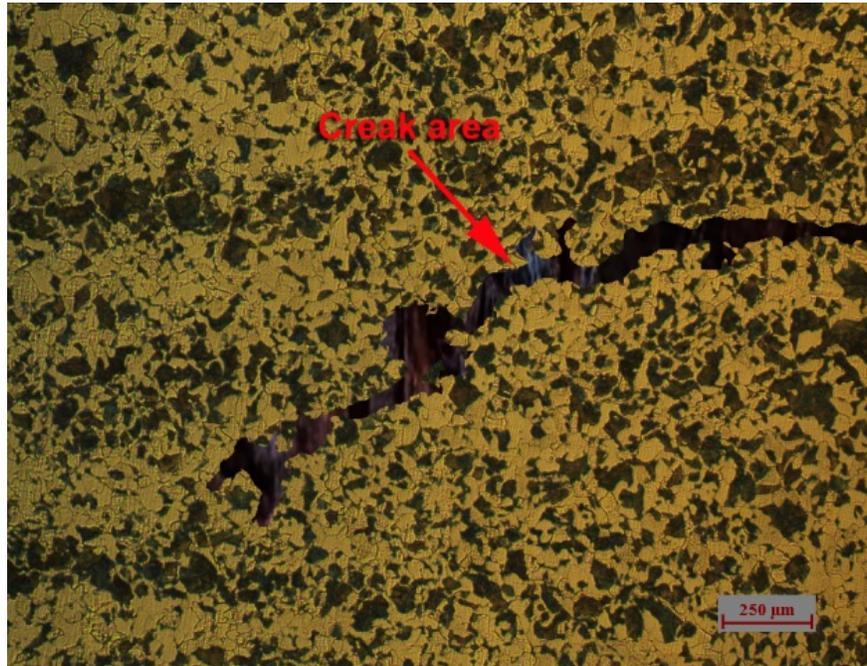
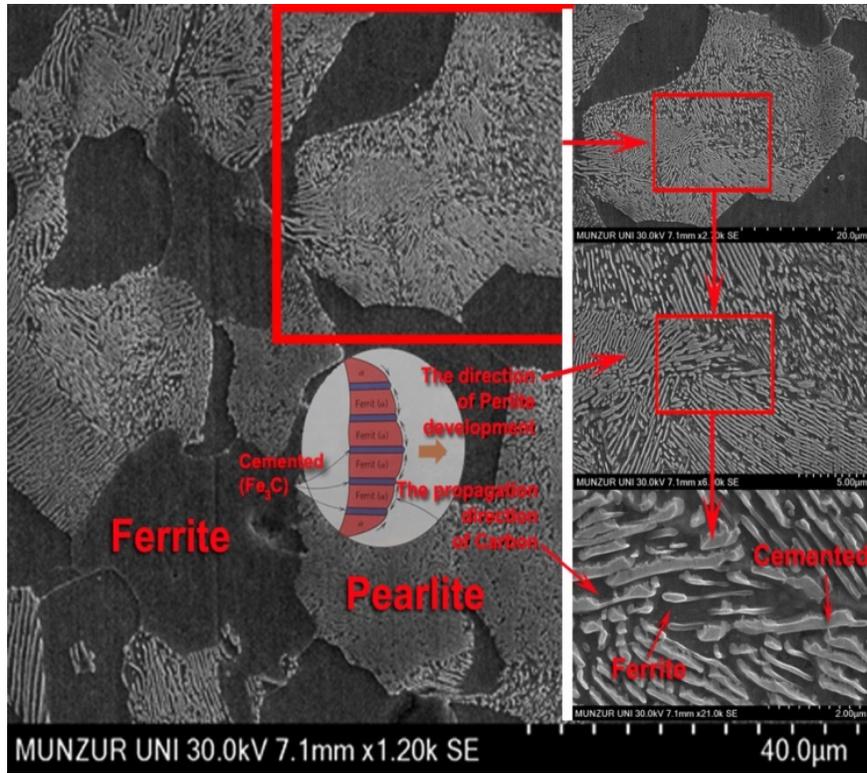
As a result of the metallographic studies carried out on the sample, we received from the area near the fracture of the fracture formation, in the optical images given in Figure 3, it is seen that the main structure (Matrix) is composed of ferrite (yellow regions), and the black regions which are scattered in the structure are perlite.

As a result of the metallographic studies applied on the sample taken from the area near the crack formation, it is considered that the progress is slow due to the thin and regular ferritic structure of the material. It is possible that the progress of the crack along the grain boundaries may be caused by dislocation within

the structure. It is clear that the main structure (Matrix) is composed of ferrite (yellow areas), and the black areas that are scattered within the structure are perlite, and there are ferrite and cementite structures within the perlite structure.

When we examine the SEM images in the different magnifications given in Figure 4, it was observed that the black regions are the main structure of the ferrite, the white areas seen as lines and layers are perlite and the structure seen as the lines is composed of the cementite forming the perlite.

Figure 4.a) Optical images at different magnifications taken from the fractured region of the bearing shell material. b) SEM

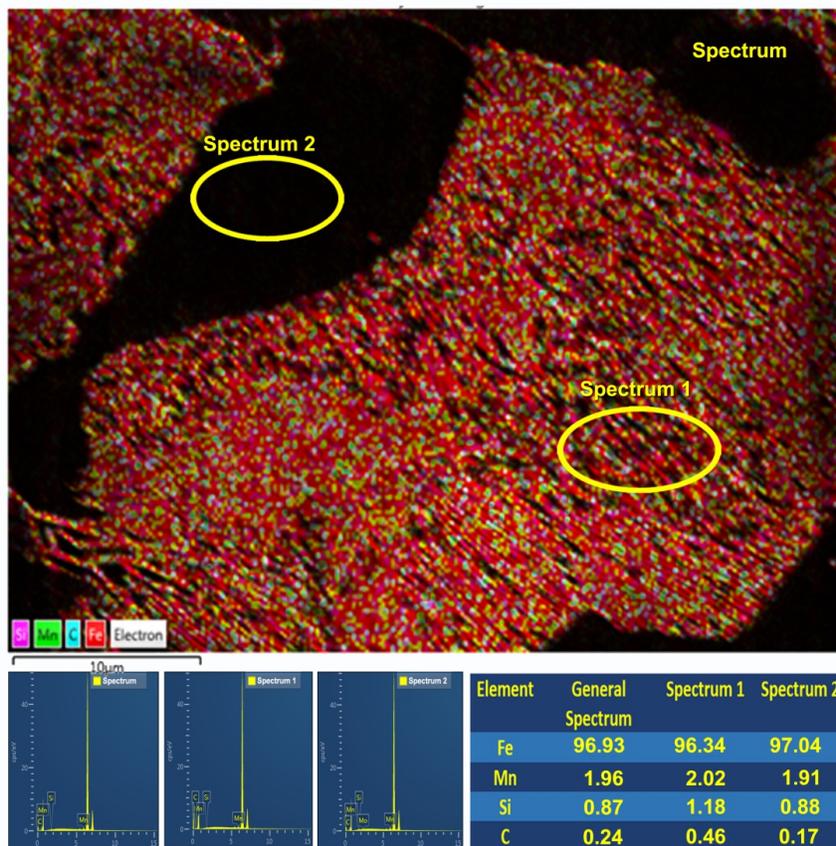
Figure 6 and 7 shows the EDS analysis that we have taken from the whole of the material and some parts of it. In the analysis we received from the overall structure, the distribution in the structure was better observed by making different coloring for each metal alloy. As a result of EDS analysis it is seen that the matrix consists of 96.93% Fe and other elements are in small amounts.

When we examine the spectrum peaks obtained from the EDS analysis, the two compounds come to the fore: in addition to compounds consisting of C, Mn and Si, compounds consisting of Fe and Mn are observed.

Figure 6. Numerical and graphical values of EDS analysis taken from the entire region or some parts of fracturing area of the bearing shell material.

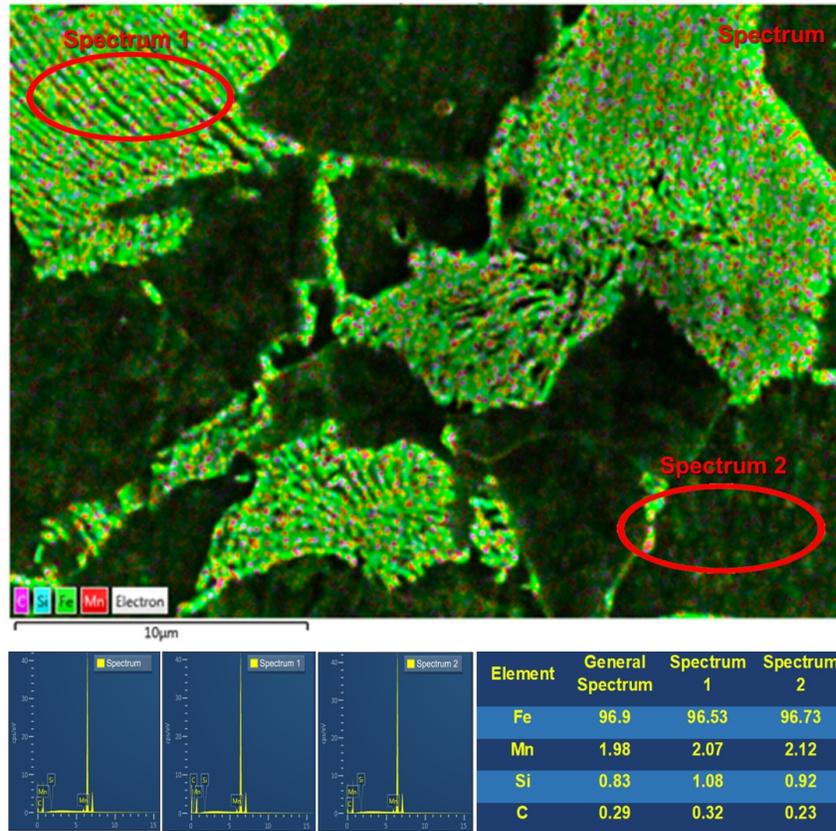
Figure 7. Numerical and graphical values of EDS analysis taken from the entire region or some parts of fracturing area of the bearing shell material
