# Late Onset Recurrent Syncope after Permanent Pacemaker Implantation

<sup>1</sup>University of Chicago

July 9, 2020

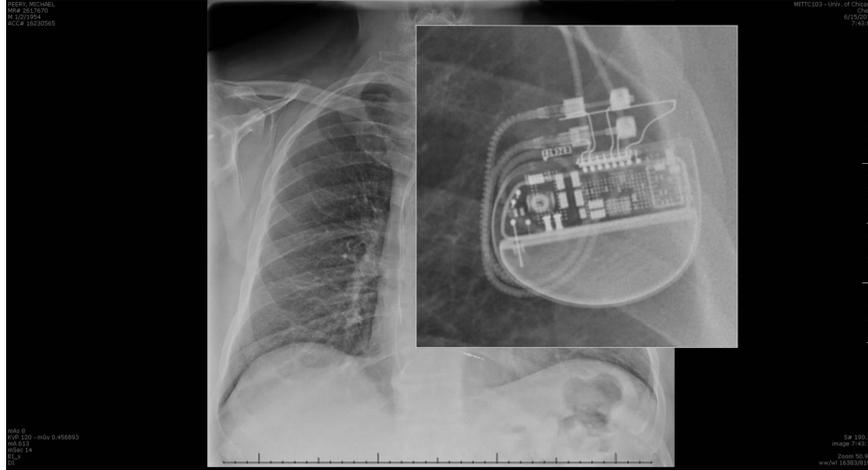
He had no further syncope after implant but continued to complain of intermittent lightheadedness as soon as a week out from the implant. Multiple pacemaker interrogations revealed stable atrial and ventricular lead function and he was told that his symptoms were likely due to low blood pressure which resulted in his blood pressure medicines being adjusted. The patient presented to his local hospital with recurrent syncope without warning 14 months after the initial implant. PPM interrogation recorded noise resulting in RV pacing inhibition (Figure 1). RV bipolar lead pacing threshold was 0.6 V at 0.4 msec and the pacing impedance measured 660  $\Omega$ . Historical RV lead pacing threshold and impedance trends were stable. RV lead oversensing was suspected and pocket manipulation, deep inspiration, Valsalva maneuver, arm isometrics, left arm extension, abduction and adduction did not duplicate the noise. The device was reprogrammed to asynchronous mode (DOO at 80 bpm) and the patient was transferred to our hospital for lead extraction.

After confirming the interrogation findings, a chest radiograph was performed which showed no obvious fracture, gross dislodgement or lead discontinuity. What is the likely cause of the noise on the RV lead and this patient’s recurrent syncopal episodes?

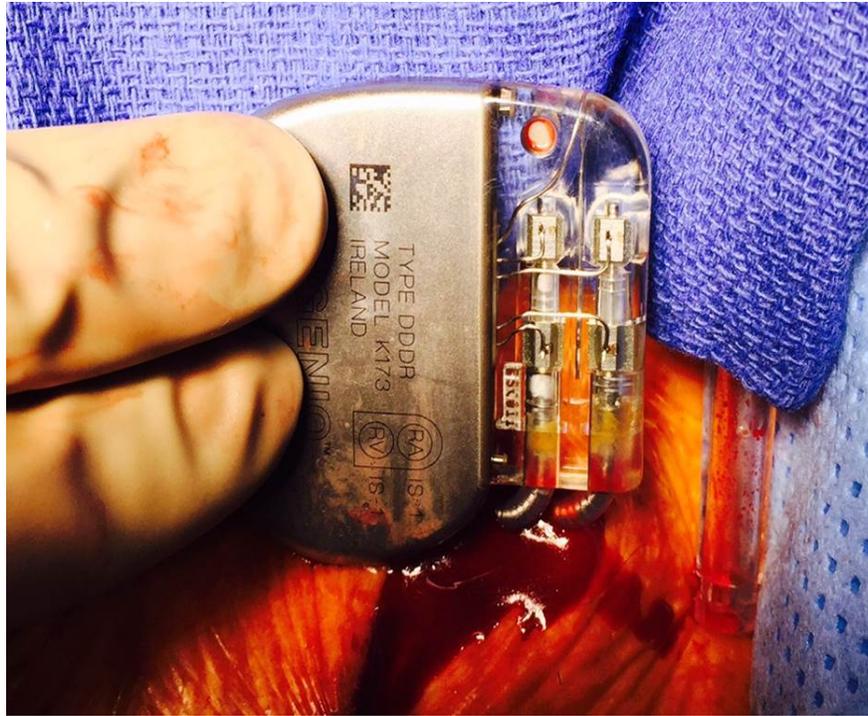
The chest radiograph revealed that the RV lead terminal pin was not fully inserted into or engaged in the pacemaker header (Figure 2). This was suspected as the potential cause for the intermittent noise. The patient was brought to the electrophysiology laboratory for lead revision. Failure of complete lead terminal pin insertion was confirmed intra-op (Figure 3). Both set screws were set but the distal set screw was not fully contacting the terminal pin. The RV lead was extensively tested using the pacing system analyzer revealing a bipolar threshold of 0.6 V at 0.4 msec and a pacing impedance of 630-660  $\Omega$ . New lead insertion or lead extraction was not performed and the RV lead was fully reinserted into the header and both set screws were tightened. At 22 months follow-up, the patient is asymptomatic without syncope or lightheadedness
