Twelve years of soil preservation and rehabilitation at Rio do Peixe watershed, promoting conservation agriculture

Abstract

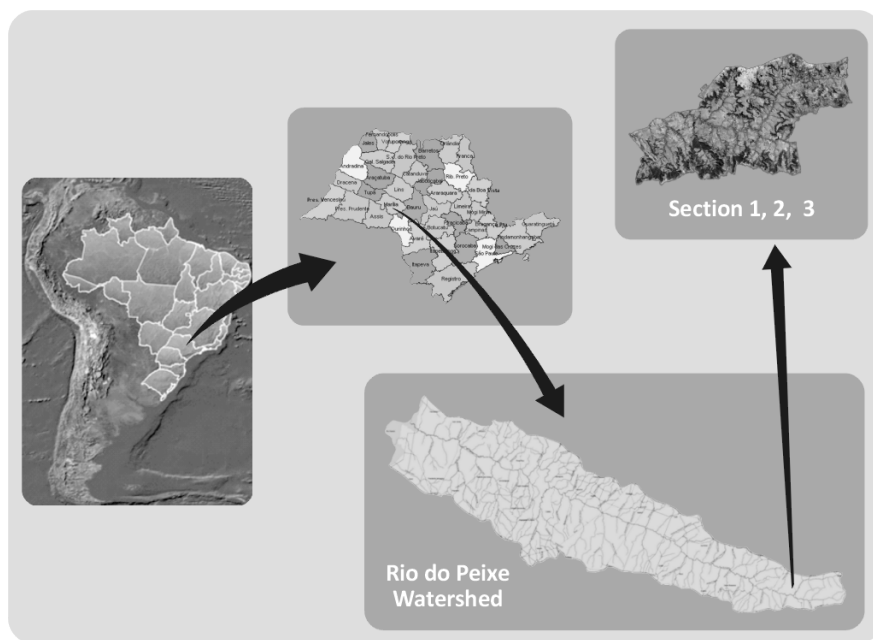
This work was carried out in the sections of Rio do Peixe Watershed, located in Vera Cruz, Ocaçu and Marília cities, SP, Brazil, at coordinates S22° 14'52.68 ", W49° 44'59.97", start and end at coordinates S22° 18'13.28 ", W50° 2'54.22", Datum WGS 84 (Figure 1).

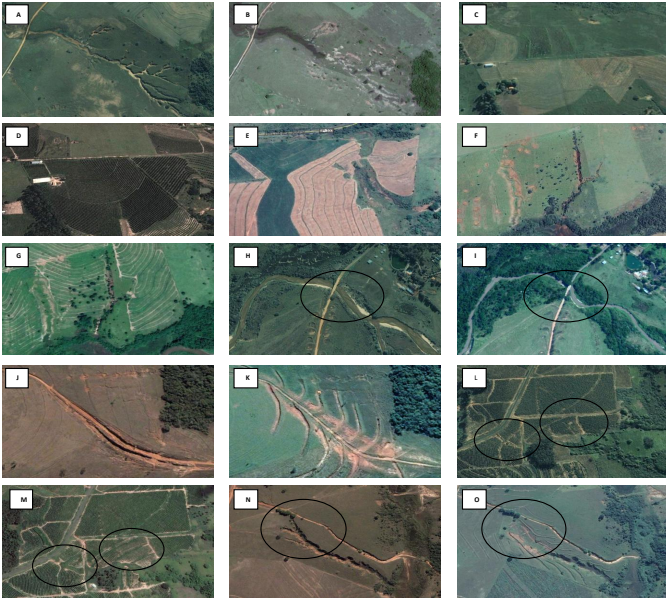
To validate the new methodology, some indicators were used to evaluate the results obtained with the implementation of soil conservation. Through the vegetation cover improvement, resulting from changes in soil and water management practices that were proven by comparing the state of the art (before evaluation/work - T1) with the results obtained (after the implementation of technical projects - T2). Using Google Earth(r) Pro images, through the historic images tool (years: 2002, 2006, 2012, 2013, 2017 and 2018) to evaluate the post-agro-environmental rehabilitation of properties (Figure 2).

Using the images from the Google Earth(r) Pro to verify the effectiveness of the works implanted in the pasture area having an erosive process (Figure 2A and 2B). Action of agri-environmental adequacy to contain the erosive processes was implemented and the control of the erosion in the area was accomplished with the construction of containment basins on areas with pastures. There was an improvement in the visual aspect of the area compared to soil conservation, in which case it was proven that pasture management with the use of containment basins favored the restoration of the area and the return of potential soil productivity.

Analysing Figures 2C, 2D, 2L, and 2M, it can be seen that the change in management in coffee culture provided a positive change in the landscape, inferring that in addition to improving the landscape with more intense vegetation cover (Figures 2D and 2M), there was an improvement in potential crop productivity. In

In Figures 2E and 2G, using the image comparison method, it can be seen that the agricultural terracing built in the area in question was efficient in controlling erosion processes at the property. According to Araujo et al. (2009) the use of appropriate management measures and erosion mitigating actions, with the recovery of the impacted areas, there will be an improvement in water quality and control of sediment production, minimizing silting and consequently, there will be an almost complete environmental rehabilitation.

The comparison between aerial images from before (T1) and after (T2) was used to assess the efficiency of the results obtained, a method that was also used by Bezerra et al. (2012) who evaluated by photocomparison the vegetation cover and the potential of water in the soil aiming at the monitoring and recovery of degraded areas, considered that the photocomparison with the supervised classification allowed to follow the development of the vegetation cover with grasses, as well as their relation to soil water potential. According to Menezes et al. (2009) using remote sensing, it was possible to verify the presence of areas already affected by inadequate management on areas with degraded pastures. These authors also highlighted the fact that native vegetation has been largely converted into pasture. Figures 2K and 2O, show the mechanical control of erosions with the construction of dams and terraces that altered the landscape of the place, previously degraded, into a pasture with productive capacity (Figures 2J and 2N). Figure 2J shows an old and eroded road that carried sediments to the bed of Rio do Peixe and which was corrected by building terraces (Figure 2K).

In section I, in Vera Cruz, 94 agricultural properties were notified, out of a total of 176 properties. They implemented conservation projects, predicting innovative measures such as improving the vegetation cover of pastures using Integrated Crop-Livestock Systems in the rebuild of them, in crops, adoption of No-tillage and bioengineering, in addition to the usual practices, such as agricultural terracing, containment basins and road readjustment (Figure 2).

adoption of conservationist practices and erosion control through the implementation of technical projects at the 228 properties that were recovered with conservationist agriculture, through the work performed (Figures 2B, 2D, 2E, 2G, 2I, 2K, 2M and 2O).

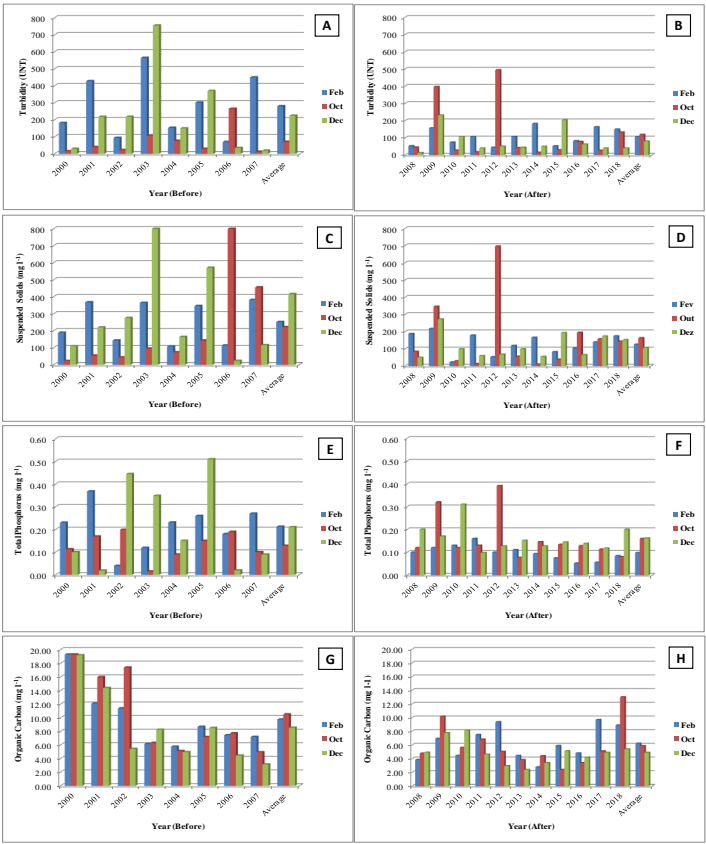
The data were obtained in two periods, considered as treatments, being: T1 - data referring to the period called BEFORE the working diagnosis and erosion control, considering the information from 2000 to 2007 and T2 - data referring to the period named AFTER the working diagnosis and erosion control, considering the information from 2008 to 2018. The improvement in water quality was assessed by determining the indicators that were tabulated and compared through graphics prepared for each indicator for the T1 and T2 treatments (Figure 3).

The improvement in water quality caused by the control/minimization of erosive processes and sediments carried to the watercourse were confirmed by the water quality indicators: Turbidity, Suspended Solids, Phosphorus and Organic Carbon, analyzing the representative graphics of these analyses (Figure 3).

The Turbidity of the water evaluated from 2000 to 2007, considered as before the work was carried out (BEFORE - T1), presented average values of 192 NUT (Nephelometric Units of Turbidity), against the average values of 102 NUT, evaluated from 2008 to 2018, considered as after the completion of the work (AFTER - T2), a decrease of 53% in the average values. For the T1 treatment, the values were higher than the Conama standard (Conama, 1986), which is 100 NUT (Figure 3A), in the average of February and December. In T2 treatment, the average values were 102 NUT, except for February 2009, 2014, 2017 and 2018; October 2009, 2012 and 2018; December 2009 and 2015 (Figure 3B).

Analysing the turbidity data, suspended solids, phosphorus and dissolved organic carbon (Figures: 3 - A, B, C, and D), it ensures that the data from treatment T2 are more uniform or stable than in T1 for these indicators. When analysing Figures 3A and 3B, related to water turbidity, in previous years the implementation of the work (T1) and after the implementation of the work (T2), it observes that, on average, water turbidity was lower in February and December when we compare (T2) with the situation before the implementation of the work (T1). This difference seen in T2 can be explained by the decrease in the supply of sediments in the watercourse. It happened because of the effects of the change in soil management with the

As for suspended solids, the highest values were recorded in T1 treatment (Figure 3C) compared to T2 (Figure 3D), in February all values were bigger than 100 mg l⁻¹ (milligrams per litre), with an average of 252 mg l⁻¹ for that month. The same happened with the values of October 222 mg l⁻¹ and in December with an average of 416 mg l⁻¹. In T2, the values were more uniform, with averages of 126, 163 and 107 mg l⁻¹, only with a peak of 696 mg l⁻¹ observed in October 2012 (Figure 3D), however, it was still below the peaks recorded in the T1 in October 2006, which was 884 mg l⁻¹ and the peak observed in December 2003 with 1850 mg l⁻¹ (Figure 3C).

The total phosphorus dissolved in water in T1 (Figure 3E), presented values higher than those recommended by CONAMA Resolution 20/86, which is 0.025 mg l⁻¹, compared to T2 (Figure 3F). The values of phosphorus for T2 of 0.10, 0.16 and 0.16 mg l⁻¹, for February, October, and December, respectively, were below the values of 0.21, 0.13 and 0, 21 mg l⁻¹, except for October, the values observed in T1 were higher than those recorded in T2, except for the peaks recorded in December 2010 and October 2009 and 2012, which reached more than 0.30 mg l⁻¹, even below the peaks that occurred in T1 in 2001, 2002, 2003 and 2005, which reached 0.50 mg l⁻¹, in December 2005 (Figure 3E).

2000. In treatment T2, the average carbon values of 6.25, 5.88 and 4.90 mg l⁻¹, for the same months, were between 4.9 and 6,2 mg l⁻¹ (Figure 3H) while at T1, they were between 8.5 and 10.5 mg l⁻¹(Figure 3G).
