# The failure process of the filled loess slope triggered by groundwater using a flume test

May 15, 2020

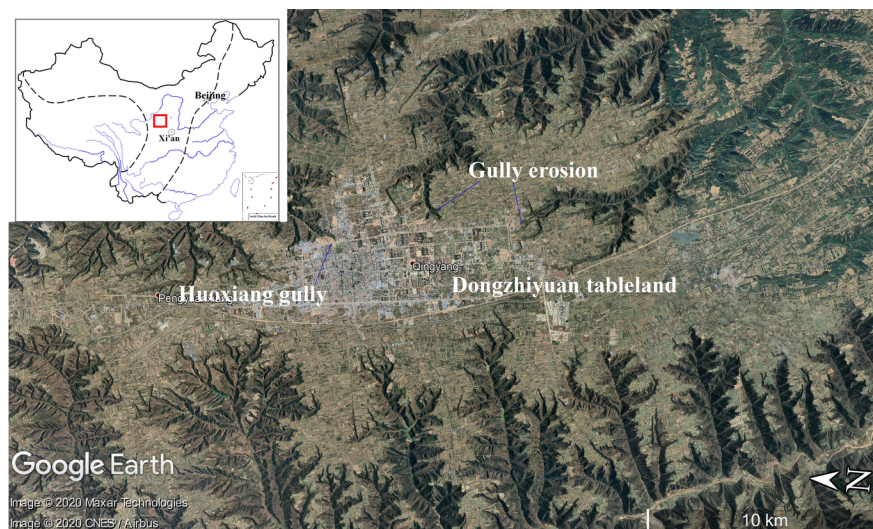
Figure 1 Gully erosion in the Dongzhiyuan tableland, where the highland is fragmented

project has been undertaken in the Loess Plateau. For example, Qingyang in Gansu Province has carried out "GSHP" to solve the problem of retrogressive erosion in the loess tableland area, and has carried out the ditch head landfill work on 14,035 gullies in the Dongzhiyuan tableland. According to the data from the Qingyang Water and Soil Conservation Administration, the area of soil erosion in the Dongzhiyuan tableland has accounted for more than 96% of the total area, where approximately 66 million tons of silt has been transported to the Yellow River each year; and in some regions, the highland was already collapsed (Xifeng Soil and water conservation Observation station of Yellow River Conservancy Commission of the Ministry of Water Resources, 2005). In 2017, Qingyang completed the gully protection project with an investment of 152 million yuan. At the same time, the Management Committee of the Middle and Upper Reaches of the Yellow River has implemented plans to carry out GSHP for erosive gullies threatening the Loess Plateau over the next 20 years.

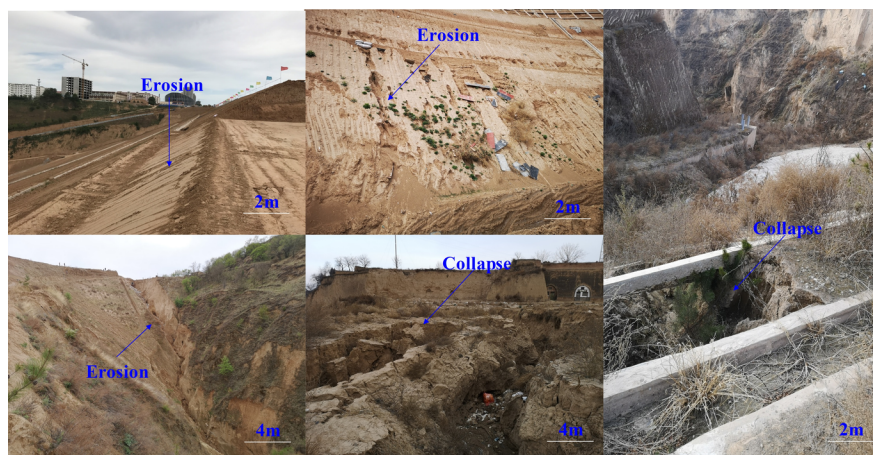
Figure 2 The Gully Stabilization and Highland Protection projects damaged by erosion

However, according to our field investigation, it was found that all projects suffered erosion damage within one year (Figure 2). In the GSHP project, the remodeled loess ditch was filled with rolling backfill, which destroyed the original loess structure, and changes the circulation of groundwater and surface water, leading to a rise in groundwater (Yin et al., 2016; Zhao et al., 2018; Wang et al., 2018). It is known that remolded loess is more likely to collapse and lose its strength under water action. According to experiments, even the dry density of remolded loess is more than that of undisturbed loess and the strength of remolded loess will sharply decrease and collapse after water infiltration occurs (Yang et al., 2003; Wang et al., 2018). The existing gully head is often the discharge outlet of the groundwater in the tableland area. Once filled, it will lead to a large amount of groundwater converging on the filled loess, which will soften the filled loess and lead to filled loess instability. For example, the remolded loess filled the groundwater channel, which resulted in groundwater rising and infiltrating the filled loess, then a landslide occurred in 2011 shortly after the project and buried the county square and affected the deformation of residential buildings in the Dongxiang County of Gansu Province (Zhuang and Peng 2014). A gully was filled with the remolded soil in Shichuan Town, Lanzhou, and the filled remolded soil failure in 2015 was due to the groundwater rising and water infiltration, and then the failure changed to debris flow forming the landslide-mudflow chain disaster event (Zhang et al., 2019). The erosion phenomenon and groundwater rising have already appeared in the Gully Stabilization and Highland Protection project (Singh et al., 2010; Jin et al., 2019). The Gully Stabilization and Highland Protection project will face failure risks due to erosion and rising groundwater. Nature has published a comment article and called for the implementation of relevant research projects as soon as possible to deal with the various new problems brought about by major engineering construction (Li et al., 2014).

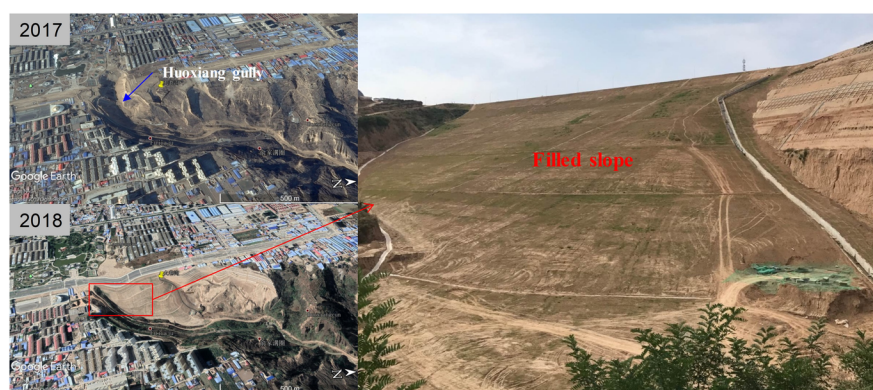
Figure 3 The GSHP in the Huoxiang gully

In this paper, the Huoxiang gully, which has been carried out by the GSHP in 2017 and finished in 2018 is taken as a case study. Huoxiang gully, located in the east of the Dongzhiyuan tableland, belongs to the Malian River basin. The gully erosion and the soil erosion in the Huoxiang gully have become increasingly serious over the past 15 years due to water drainage from the city. The gully back erosion is more than 30 m with an average annual head back erosion of more than 2 m since 2004, and the cut erosion has increased to 40 m. The continuous head back erosion poses a great threat to the local people. So, the GSHP project was carried out and the head of the gully was filled in 2017. According to the DEM (tandem with 5 m resolution) pre-filled and the design of the filled project, the maximum landfill depth is 80 m and the width is 300 m (Figure 3).

From the topographic map and field investigation, the altitude of the head of the Huoxiang gully is lower than that of the Dongzhiyuan tableland surface and the head of the gully is the groundwater outlet of the tableland before landfilling. The GSHP changes the circulation of groundwater and surface water, leading to a rise in groundwater. The groundwater infiltrates into the filled project and softens the filled loess, resulting in filled project failure.

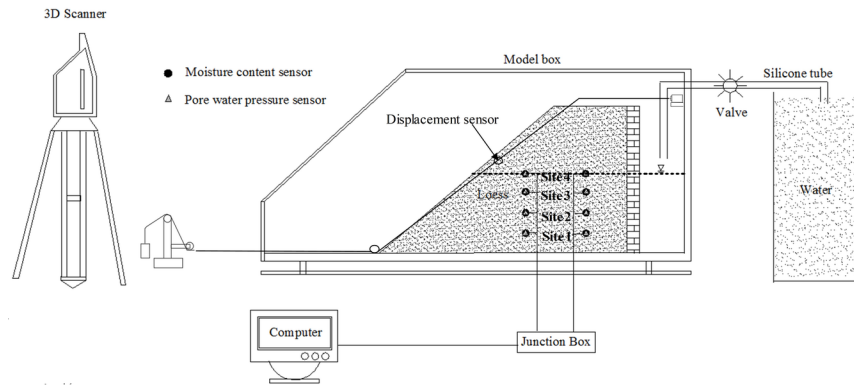
Figure 4 Schematic drawing of the groundwater uplift test flume setup

The device consists of three parts: slope flume, rainfall operator, and data acquisition system. The slope flume is a three-dimensional experimental loess slope constructed in a  $2 \text{ m} \times 0.6 \text{ m} \times 1.2 \text{ m}$  (length  $\times$  width  $\times$  height) box with glass sidewalls and a metal frame (Figure 4).

The data acquisition system is composed by nine EC-5 volumetric water content sensors, each with an accuracy of  $\pm 2\%$ , nine MKM pore-water pressure sensors and a displacement sensor with an accuracy of  $\pm 0.1 \text{ mm}$ , that were installed at specific depths as the slope was constructed. The sensors were each connected to two Em50 data loggers. The sensors were calibrated before each experiment.

To accurately simulate the rising groundwater and infiltration into the filled project, the groundwater was recharged through the concentrated channel by locating the drainage plate and temporary water tank at the rear of the experimental model. The water in the temporary water tank was kept at a constant height of 40 cm. The drainage plate was set in five rows spaced at 20 mm, whereas the columns were spaced at intervals of 20 mm. The diameter of the drainage holes was 2.0 mm to ensure that the groundwater was able to infiltrate into the slope evenly.

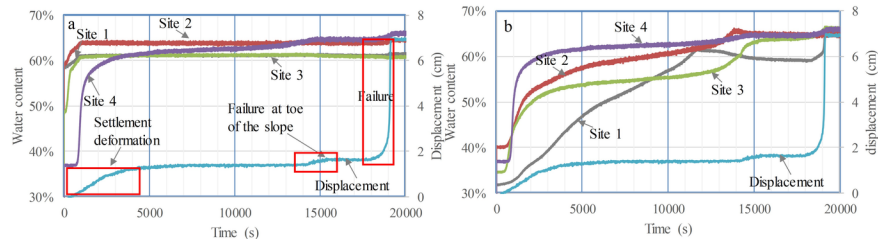
Figure 5 Change in water content of the slope vs. time at different positions (a: position at back of the slope; b: position at front of the slope)

deformation of the slope with infiltration into the slope. The cracks appear in the slope due to deformation resulting in the groundwater forming preferential seepage along the cracks and entering the soil quickly. Figure 5 shows the change in water content of the slope vs time at different positions. The water content at the back of the experimental slope increases immediately with increasing groundwater levels, and the water content at the front of the experimental slope relatively increase later. Meanwhile, the upper water content increases slowly due to the groundwater increasing from bottom to top. Then the groundwater continues to infiltrate from the back of the slope and seeps out from the toe of the slope. The water transfer path formed, and the slope failure occurred at 316 mins. The water content near the slope toe at 20 cm responds to the failure and increases quickly, which shows that the slip surface is near this area. The hydrostatic pressure near the sliding surface increases during failure, resulting in increasing water content, which indicates that the shear contraction appears in the sliding surface.

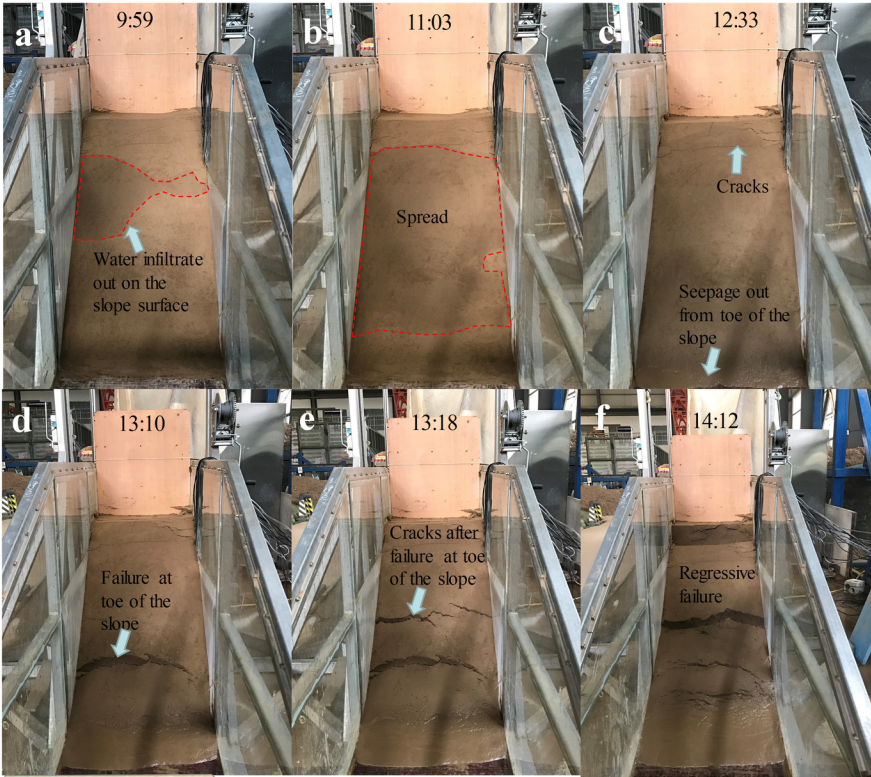
Figure 6 Water infiltration process

During the test, although the groundwater seeps out from the middle of the slope surface and then spreads to the slope toe, the slope is still stable even if the middle of the slope is saturated. Until the groundwater seeps out from the slope toe, the slope begins to fail via the retrogressive sliding process (Figure 6). This phenomenon shows that the slope would not fail due to saturated soil in any area of the slope and will fail due to the key part of the slope saturation. The stress distribution of the slope is uneven and concentrated at the slope toe, resulting in this area being prone to failure. The slope toe fails first and makes the upper part fail resulting in a regressive landslide. This phenomenon is consistent with that observed at Heifangtai, most of the landslide at Heifangtai failure until the seepage out from the slope toe and the slope toe failure first and then makes the upper part failure resulting in forming regressive landslide. The results show that the key blocks have great influence on the stability of the slope.

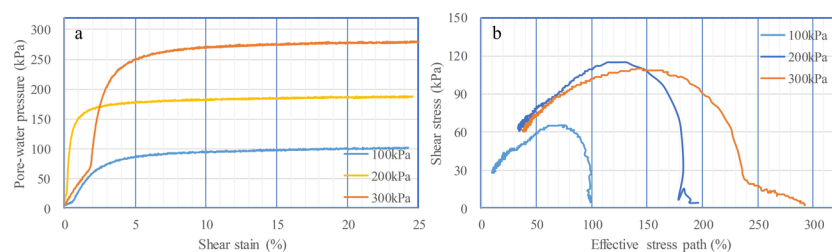
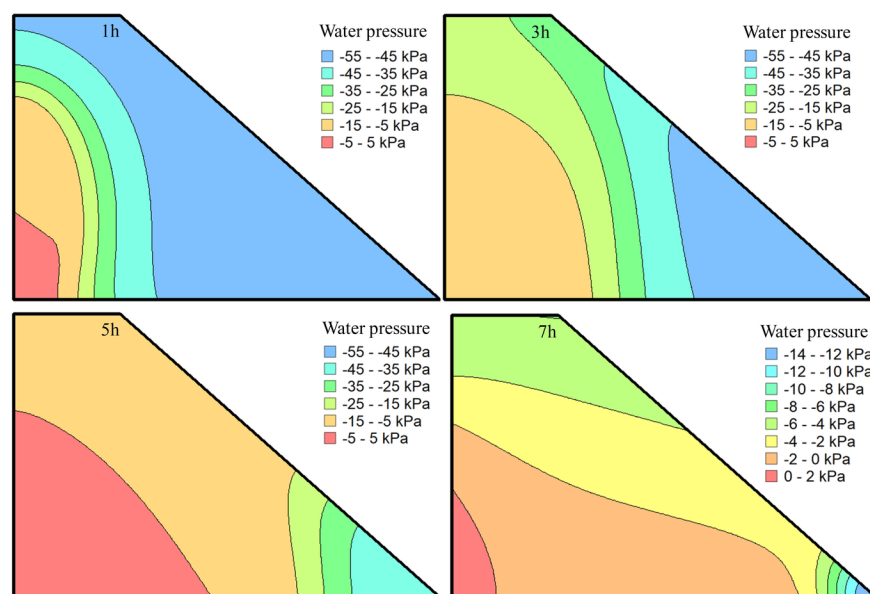
Figure 12 Water pressure variation of the slope

There is a difference level of seepage water in the process of groundwater infiltrating to the front of the slope due to the rise in groundwater resulting in seepage pressure in the experimental slope. To study the change in seepage pressure of the experimental slope during groundwater rising, a two-dimensional slope with  $40^\circ$  was established using a sigma/W module based on the results of the experiment. The shape and soil parameters of the simulation slope are the same as that of the experimental slope protected by a flat slope in the physical model experiment. The lower boundary of the simulation slope is set as the impermeable boundary (unit flow is zero), the left boundary is set with a constant head of 50 cm, and the other boundary is set as the default boundary, and the simulation process lasted for seven hours.

Figure 12 shows the water pressure distribution at different times. In the early stage of the test, the water pressure of the slope develops in a diffusive way. The soil mass at the place of groundwater infiltration changes first, and the water pressure gradually rises and tends to stabilize. The variation area of water pressure extends from the back edge of the slope to the front edge of the slope. The water pressure of the slope shows obvious stratification in the horizontal direction, and the infiltration of water pressure along the back edge of the slope gradually decreases towards the front of the slope. There is a water pressure gradient from the back of the slope to the front of the slope. The water pressure gradient will increase the probability of slope instability, reduce the stability of the slope, and promote the slope failure.
