# Minimally-invasive surgical explantation of a partially detached Cardioband device

Transcatheter repair systems are becoming increasingly popular as a potential solution for high-risk and inoperable patients with mitral regurgitation. The Cardioband (Edwards Lifesciences, Irvine, California) is a transcatheter direct annuloplasty device, based on the concept of an undersized ring annuloplasty. We report a case of minimally invasive surgical explantation of a failed Cardioband device 21 months after its implantation. Intraoperatively, it was found that 3 anchors of the Cardioband device were detached from the posterior annulus at P2. In this report, a “cut and unscrew” technique with some tips and tricks is presented for the removal of the device.

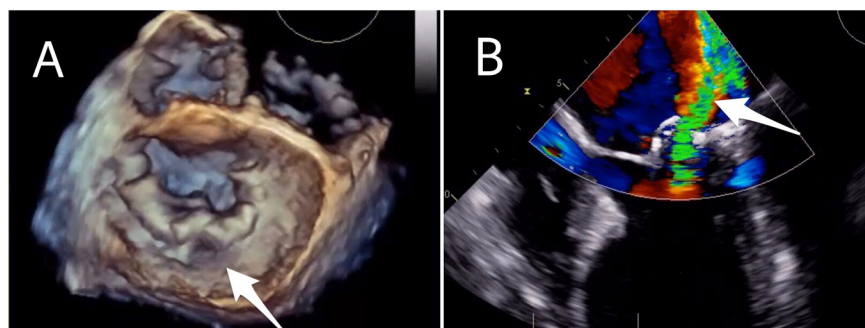
**Figure 1:** 3D transesophageal echocardiographic image shows a partially detached device at P2 (A). Severe mitral regurgitation with two jets originating from the anterior and posterior aspect of dehiscent device (B).

On admission, TEE showed left ventricular systolic dysfunction (ejection fraction 45%), dehiscence of the Cardioband at P2 and severe MR with two jets originating from the anterior and posterior aspect of dehiscence

part of the device (Figures 1A and 1B). After multidisciplinary heart team discussion, the patient was scheduled for a minimally invasive mitral valve replacement, with a STS-PROM score of 6.08%.

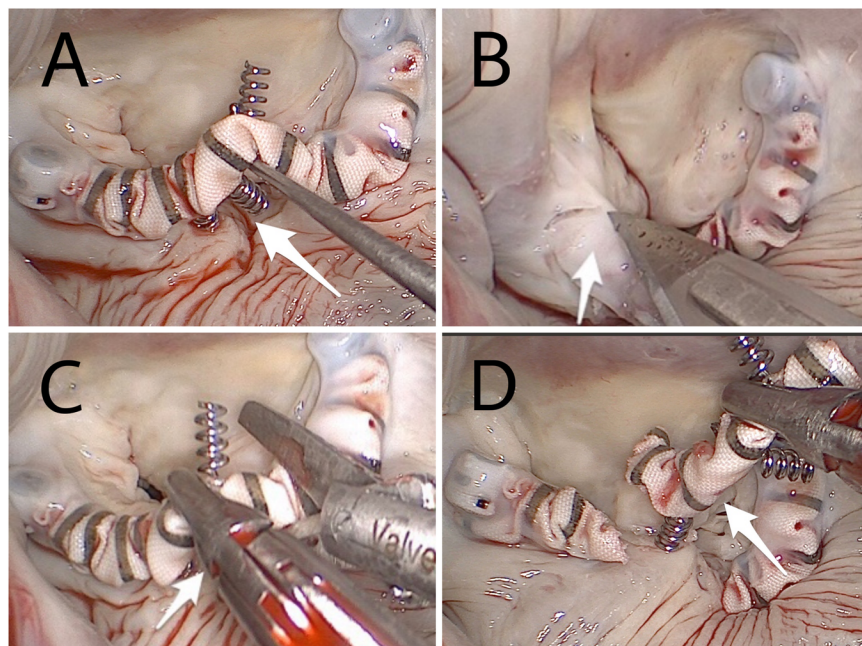
**Figure 2:** Intraoperative findings: A detachment of the 3 anchors of the Cardioband at P2 (A). The highly-endothelialized part of the device was dissected from the surrounding annular tissue via scalpel (B). The Cardioband was cut between the anchors and the anchors were unscrewed by counter-clockwise rotation (C, D).

A minimally invasive approach through a right anterolateral minithoracotomy was performed and the mitral valve was visualized using a three-dimensional (3D) endoscope. An endocardial ablation procedure was performed using AtriCure Cryo Module (AtriCure, Inc., West Chester, OH). Intraoperatively, it was found that 3 anchors of the Cardioband were detached from the posterior annulus at P2 and the remaining part was highly endothelialized (Figure 2A). The highly-endothelialized part of the Cardioband was dissected from the surrounding annular tissue via scalpel and electrocautery (Figure 2B). Care was taken to avoid injuries of the adjacent structures such as the coronary sinus and the circumflex coronary artery; every effort was made to maintain the annular structure to avoid atrioventricular groove disruption. The time consuming part of the procedure was the removal of the Cardioband by applying a “cut and unscrew” technique. To facilitate the removal, the Cardioband was cut between the anchors and the anchors were then unscrewed by counter-clockwise rotation (Figures 2C and 2D). These manoeuvres were performed repeatedly until the last anchor was removed. Since the likelihood of successful mitral repair was considered low, due to the valvular morphology, a St. Jude Medical Epic bioprosthetic mitral heart valve (St Jude Medical, Inc, St Paul, Minn) was implanted and fixed using Cor Knots (LSI SOLUTIONS, Victor, New York, USA).

In the presented patient, although a detachment of one of the anchors was found already during the procedure, two more dehiscent anchors were confirmed during the operation. This may have resulted from “unscrewing” of the anchors over time under high tension during cardiac contractions, especially at the P2 segment where annular displacement has the highest amplitude. This challenging problem may be overcome with procedural modifications such as increasing the number of implanted anchors at this segment.
