Role of Transesophageal Echocardiography Diagnosis of an Acute Aortic Paravalvular Leak and Successful Treatment with Percutaneous Closure

Lingcan Tan¹, Qiao Li², Yuan Feng³, and Haibo Song⁴

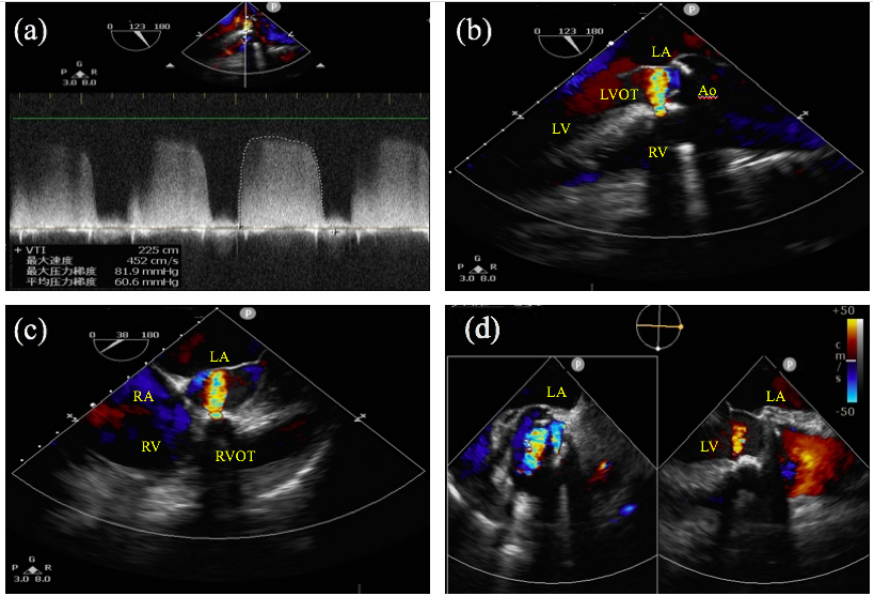
Figure 1. TEE revealing prosthetic aortic valve regurgitation outside the edge of sewing ring both from long axis and short axis view. LA, left atrium; LV, left ventricle; RA, right atrium; RV, right ventricle; LVOT, left ventricular outflow tract; RVOT, right ventricular outflow tract; Ao, aorta; TEE, transesophageal echocardiogram.

Whereas, in the apical 5-chamber view, TTE detected dubious coronary flow with velocity of 2.8 m/s in the left ventricular outflow tract (LVOT), which suspected coronary-left ventricular fistula, which neither monitored in preoperative TTE nor intraoperative TEE. Therefore, we performed a second TEE to him 3 days post-surgery, noticing a jet regurgitation in long axis view of aortic valve, which started outside prosthetic frame into LVOT, with high velocity of 4.41m/s and vena contract width of 4.7mm (Figure 1a-1b). Short axis view of aortic valve also revealed the regurgitation was paravalvular, outside the edge of sewing ring (Figure 1c-1d). PVL was highly suspectable, then subsequent ascending aortic angiography confirmed it (Figure 2). PVL diameter was calculated by angiography, showing approximate 3mm closed to aortic root. Afterwards, leak was passed by a hydrophilic terumo 0.32 inch guide wire and 5 F delivery catheter was placed into left ventricle, transcatheter occlusion was successfully made to intervene by preforming a 10mm Vascular Plug device (Starway Medical Technology Inc., Cardi-O-Fix Plug Occluder)(Figure 3a). After device was in place, second aortic root angiography revealed no sign of PVL during opening of aortic side, neither of coronary obstruction (Figure 3b). 8 days after closure, TTE showed reduced left ventricular of 50mm, left ventricular motion synchrony, slightly increased EF of 38%, as well as no observation of PVL. The patient had been discharged from hospital 26 day post-surgery, no signs of recurrence have been detected in 2 months of follow-up.

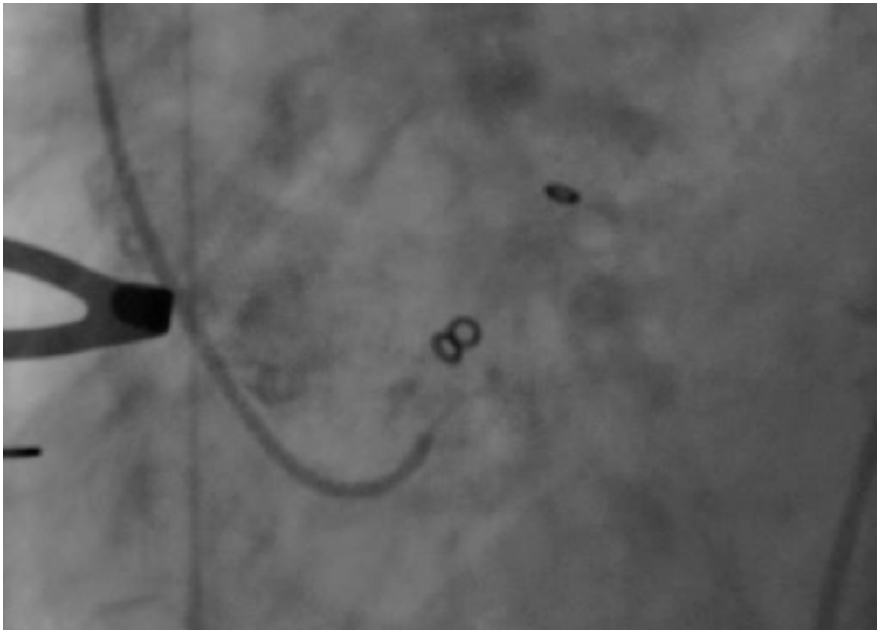
Figure 2. Aortic root angiography confirming PVL. PVL, paravalvular leak.

In our case, patient was once mistaken as coronary artery-left ventricular fistula, probably owing to limitation of acoustic shadowing, which could preclude visualization of aortic prosthetic components, resulting in misidentification of abnormal color doppler signal, and underestimate severity of regurgitation. Coronary artery fistula is an anomalous connection between coronary artery and cardiac chamber or great vessel, accounts for 0.2%-0.4% of congenital heart disease^{3}. Majority of coronary fistula opens to the right heart, very rare in the left ventricular. 2D echocardiography shows dilated and tortuous coronary artery, and associated enlarged feeding artery, sometimes appearing the origin or course of the fistula vessel^{4-6}. Color Doppler helps in detection of the entrance and termination site of drainage, characterized by continuous shunt both in systolic and diastolic period^{4}. PVL, unlike, usually appears as abnormal jet flow outside prosthetic valve frame, no course of drainage. TEE can display heart structure more clearly than TTE in real time, help quantitatively evaluate heart function and heart structure, and be simpler, cheaper and less time-consuming than cardiac angiography. In addition, multi-modality imaging, including combination of TTE, TEE and cardiac angiography, may be needed to confirm and assess coronary fistula considering the complexity of diagnosis^{1,2}. As in this case, TEE descriptions promote suspicion of PVL, and cardiac angiography confirmed it, stressing the utilization of multi-modality in PVL diagnosis.

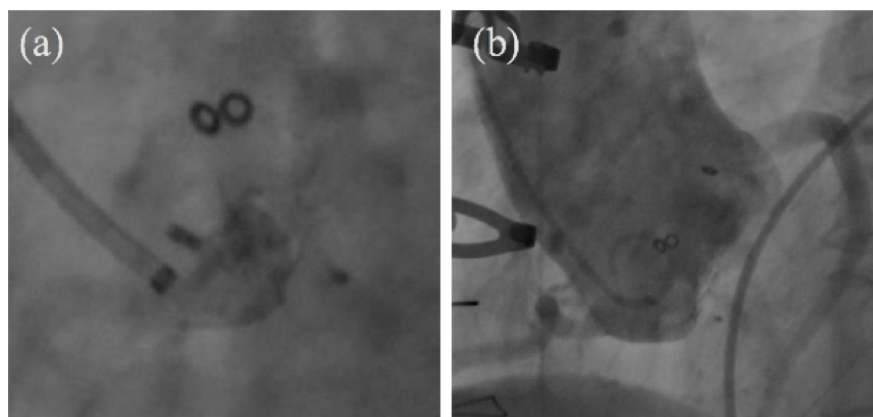
Figure 3. Releasing of Vascular Plug device after positioning PVL (a) and aortic root angiography exclude PVL following closure (b). PVL, paravalvular leak.

Previously, clinically significant PVLs could be only corrected by reoperation, whereas, along with increased mortality closely related to reoperation. In recent two decades, transcatheter closure has evolved as available option for PVL patients, especially for those who are at high surgical risk and have suitable anatomic features for transcatheter closure^{1}. In the literature, a large amount of PVL cases have been successfully closed with various occlude devices, despite that no device has been approved for PVL occlusion by FDA^{1,2,7,8}. Available devices include the Amplatzer family of occluders/plugs (St Jude Medical, St Paul, MN, USA), Amplatzer septal occluder (ASO), Amplatzer muscular VSD occluder (mVSD), Amplatzer duct occluder (ADO), and Amplatzer vascular plugs (AVP II and III). On the other hand, successful closure require experienced interventional cardiologists to be familiar to complex catheter techniques and have facility to perform. Our present report is a successful case of repair of aortic paravalvular leakage with one kind of domestic Plug device.
