# Guidewire Knot Formation

## Abstract

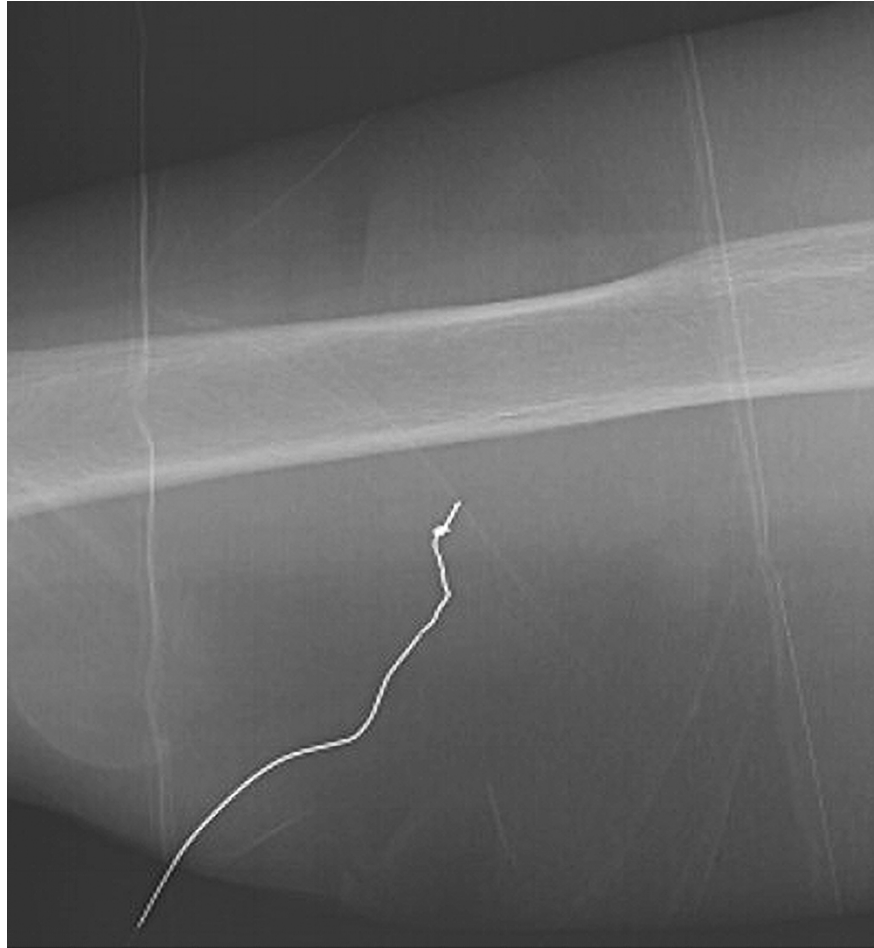
The right basilic vein of the forearm was selected and punctured using an ultrasonic guide, and a guidewire was inserted into the vein. At approximately 10 cm, the guidewire encountered strong resistance, and we were unable to remove the guidewire from the patient's body. Radiography indicated that a knot had formed at the tip of the guidewire (Figure 1).

Figure 1: Radiograph indicating a knot-like appearance at the tip of the guidewire.

As there was risk of crushing or breaking from forced removal of the guidewire, surgical intervention was performed under local anesthesia for safe removal. Intraoperative findings revealed that the guidewire had penetrated the vein wall and formed a knot outside the wall (Figure 2). No complications occurred after surgery. Although central venous access catheters are known to cause various complications, this is, to our knowledge, the first report describing knot formation of the guidewire during PICC insertion. Previous reports have shown that forced insertion or withdrawal of a knotted guidewire may cause tearing of the veins and that surgical intervention is appropriate in such cases.<sup>1,2</sup> Although this is a rare complication, it is important for clinicians to know that the guidewire can become knotted and be aware of appropriate treatment methods such as surgical intervention.

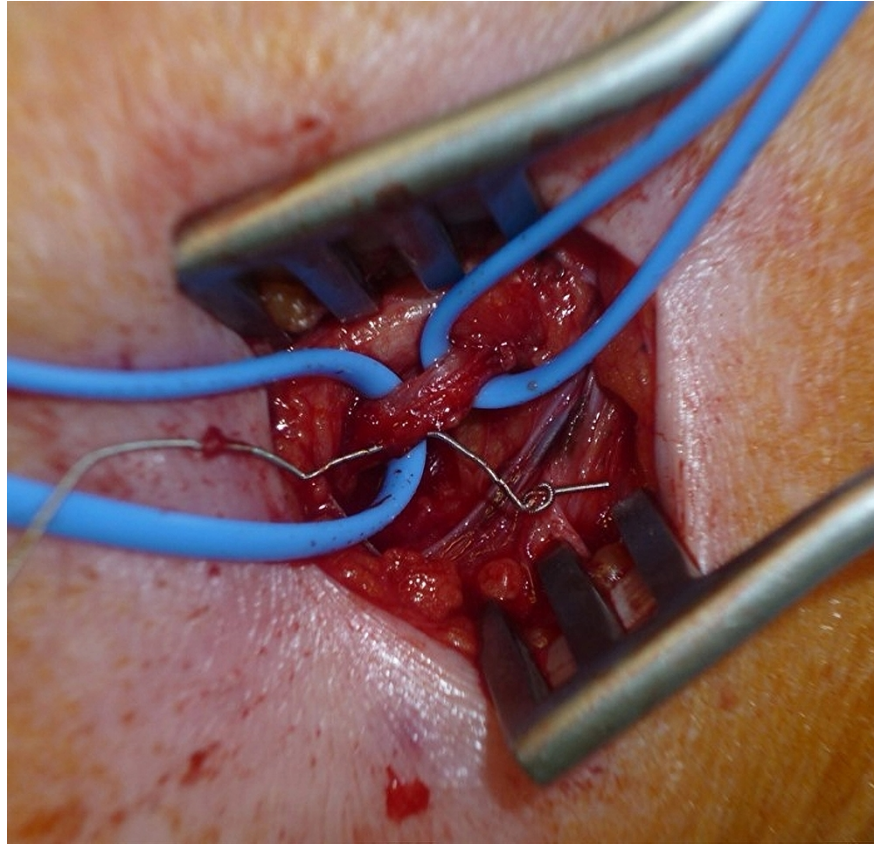
Figure 2: Intraoperative findings showing the guidewire penetrating the vein wall and forming a knot outside the vein.
