Pneumothorax leading to pneumopericardium after transvenous lead implantation in a patient with a previous epicardial lead

September 11, 2020

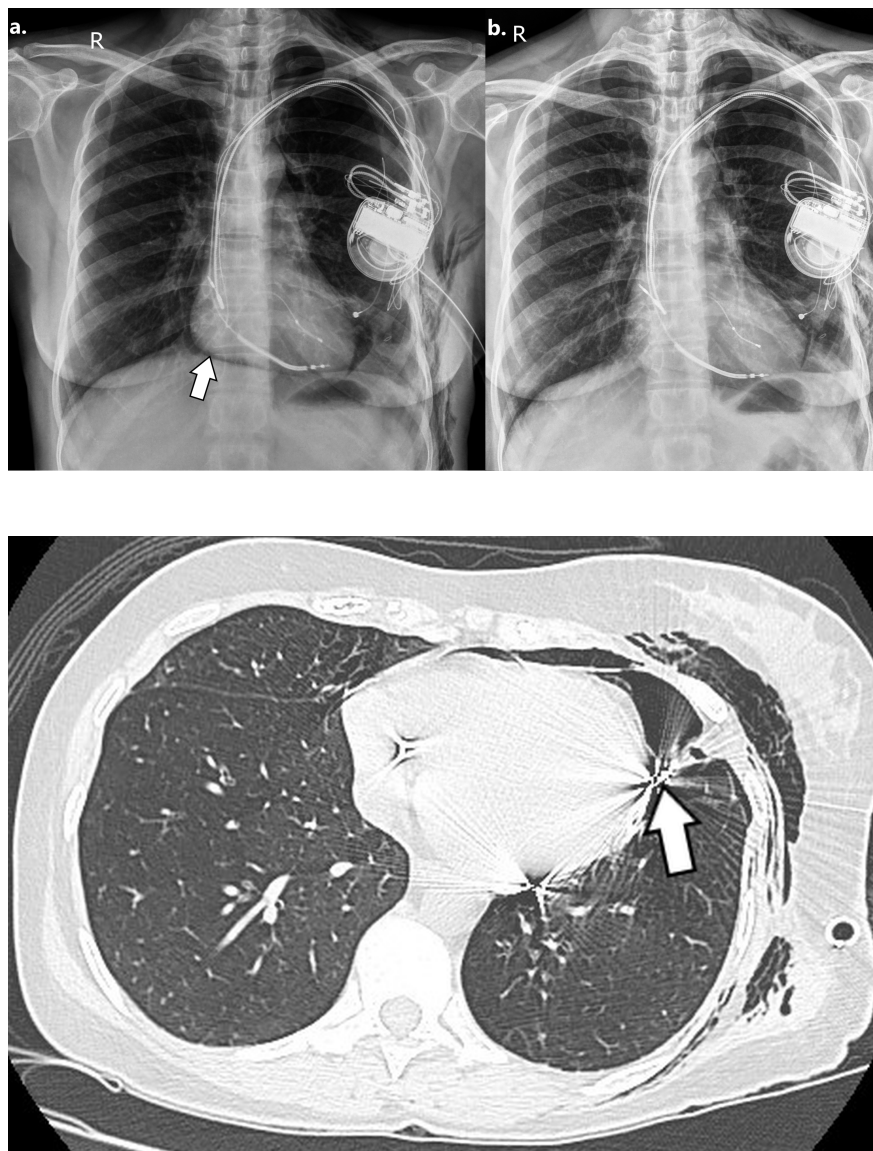
Figure 1. a. Chest X-ray frontal view soon after left intercostal tube drainage, showing pneumopericardium (bold arrow) and left pneumothorax. **b.** Chest X-ray frontal view after 3 days, demonstrating complete resolution of pneumothorax and pneumopericardium.

A good electrocardiographic result with narrowing of QRS complex, prominent R wave in lead V1 and superior QRS axis were obtained. However, the patient complained of deteriorating dyspnoea the next day. Examination was suggestive of left pneumothorax with diminished breath sounds and tympanic note on percussion. Chest X-ray confirmed the diagnosis of a large left pneumothorax and surprisingly also revealed a pneumopericardium. A left pleural drain was immediately placed (**Figure 1a**). Transthoracic echocardiography was inconclusive due to a poor window, but the Doppler derived hemodynamics were not suggestive of cardiac tamponade. To help clarify the cause of pneumopericardium a CT scan of the chest was performed, which confirmed the presence of pneumopericardium, along with extrathoracic emphysema (**Figure 2**). It further revealed a connection between the left pleural and pericardial cavities around the epicardial lead, which allowed air to track from one to the other. The chest X-ray three days after intercostal drainage revealed resolution of pneumopericardium and pneumothorax (**Figure 1b**) and the patient was subsequently discharged. The patient continued to do well on follow up after 6 months.
