Pericardial effusion caused by accidentally placing a Micra™ transcatheter pacing system into the coronary sinus

Abstract

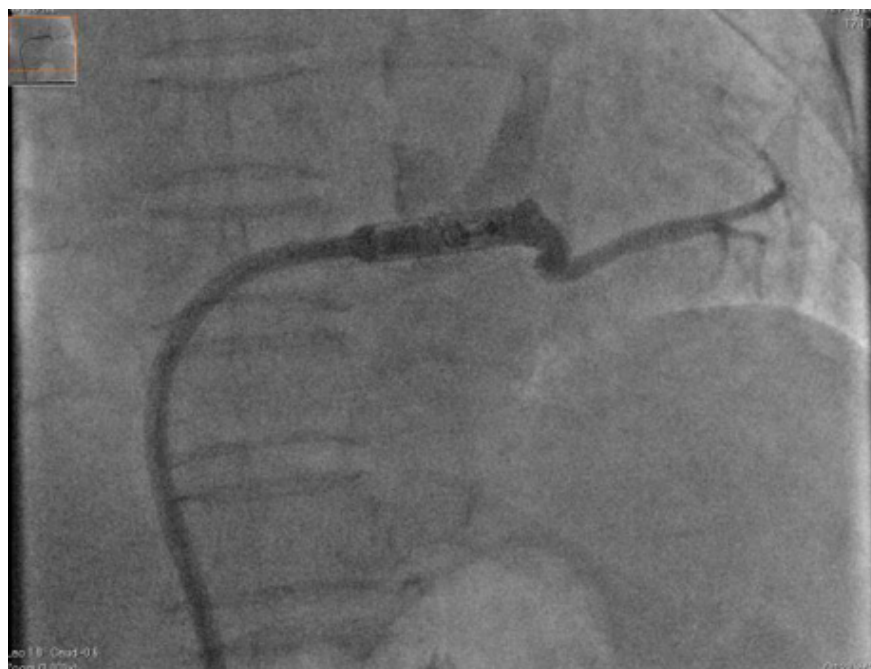
Figure 1. Angiography showing Micra TPS placing into the coronary sinus: A. At poster-anterior view; Pericardial effusion (arrow) at left anterior oblique view for the first attempt (B) and the second attempt

(C).

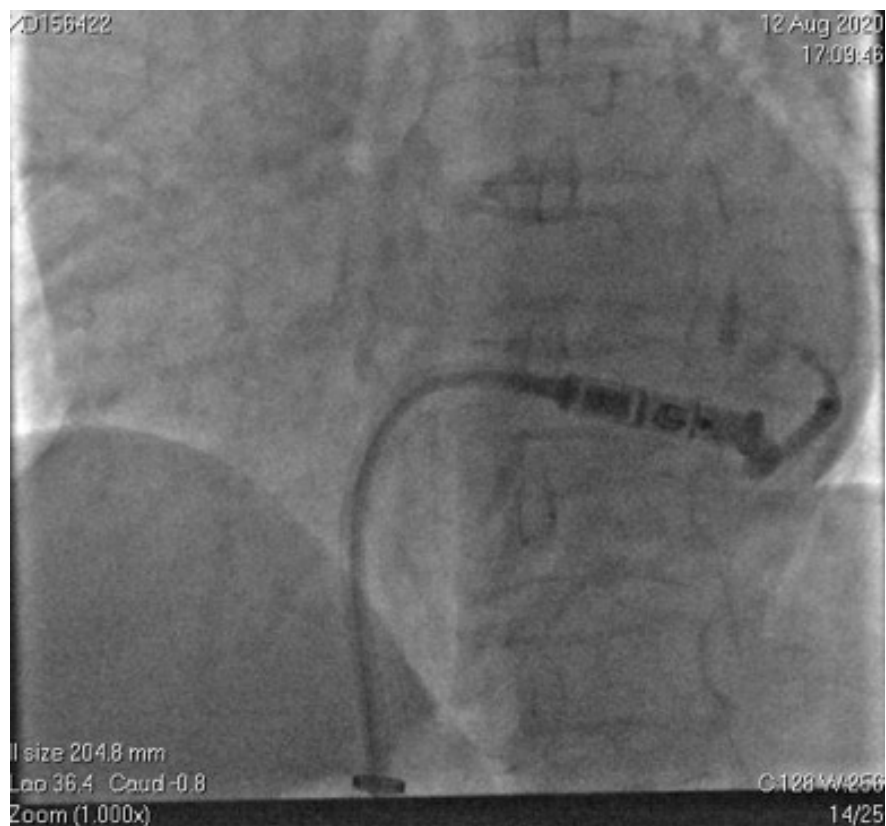
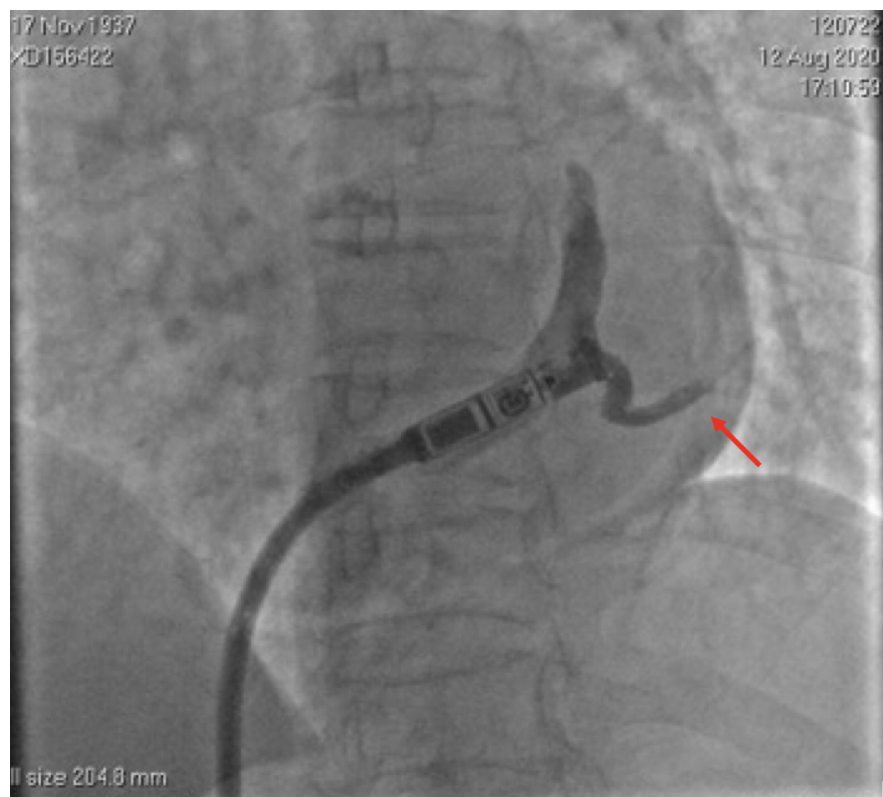
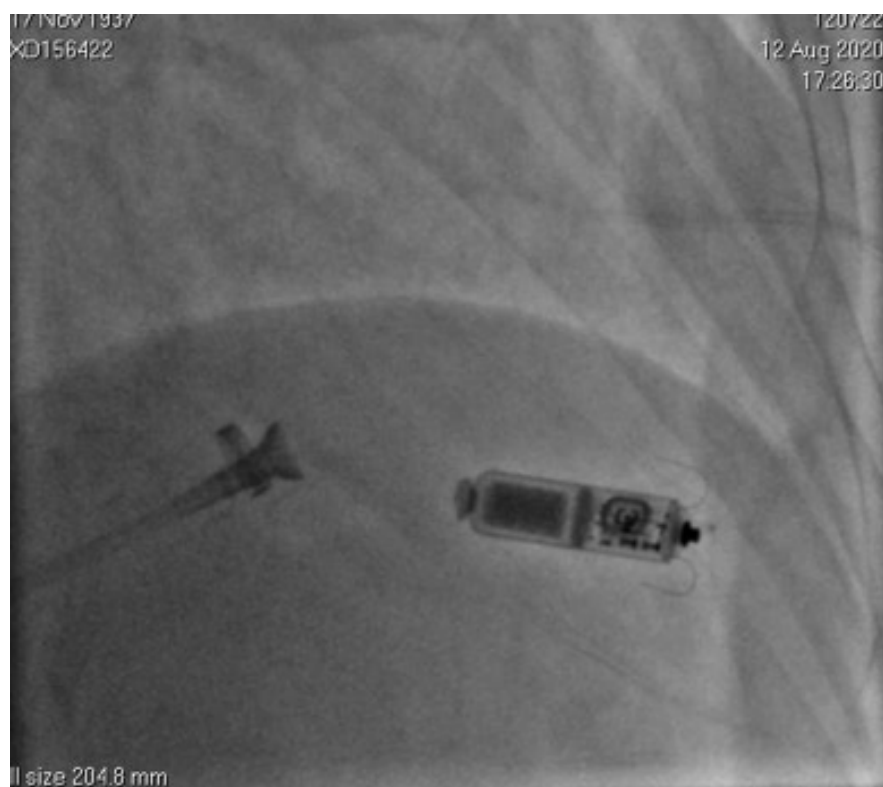
Figure 2. The images showing the location of Micra leadless pacemaker: A. After deployment at right anterior oblique view; B. CT scan after implantation indicating the leadless pacemaker locating at the apex of right ventricular

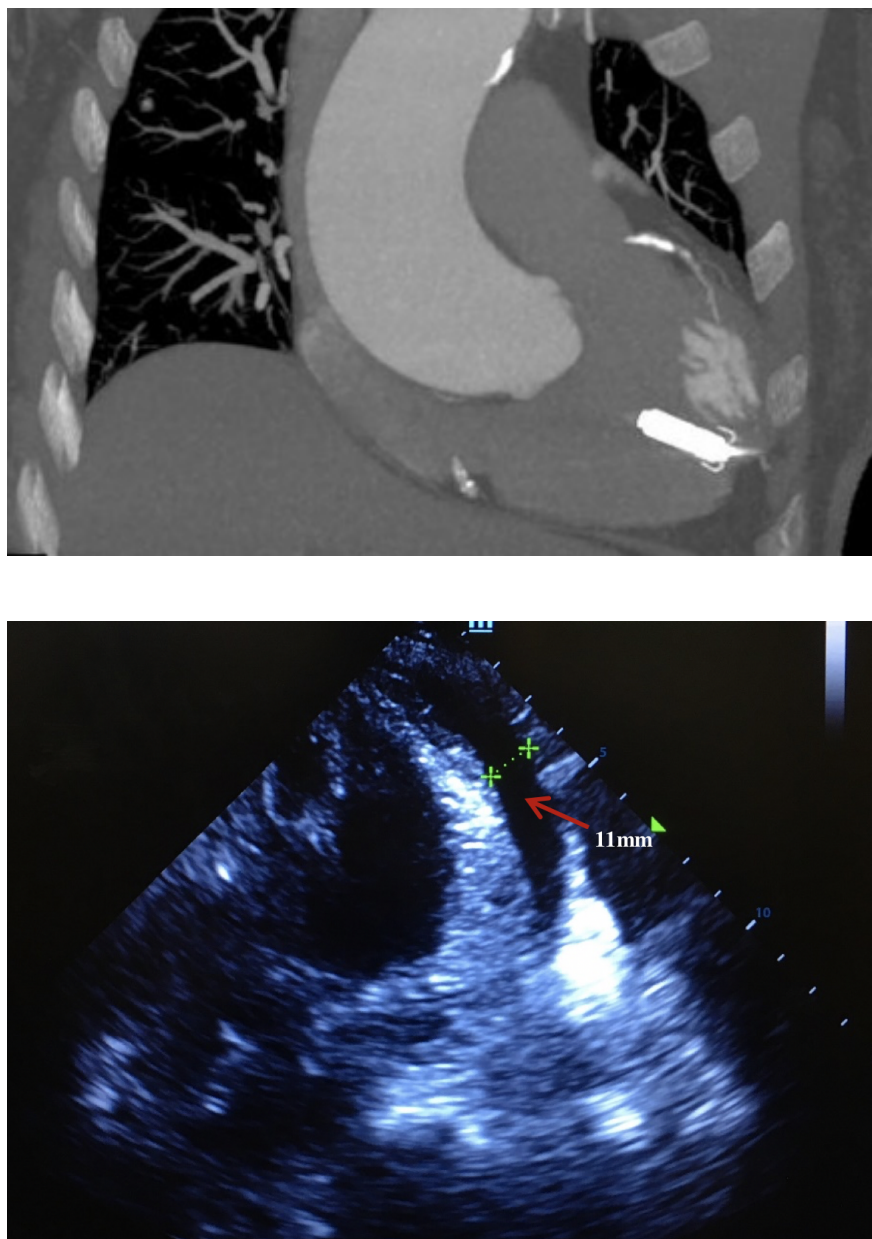
Figure 3. The echocardiogram showing pericardial effusion (red arrow) during diastolic phase mainly distribution around the posterior wall of left ventricle.
