Spontaneous mechanical aortic valve leaflet dislocation during implantation

Emmanouel Papadakis¹, Thomas Martens², and Meletios Kanakis³

December 26, 2020

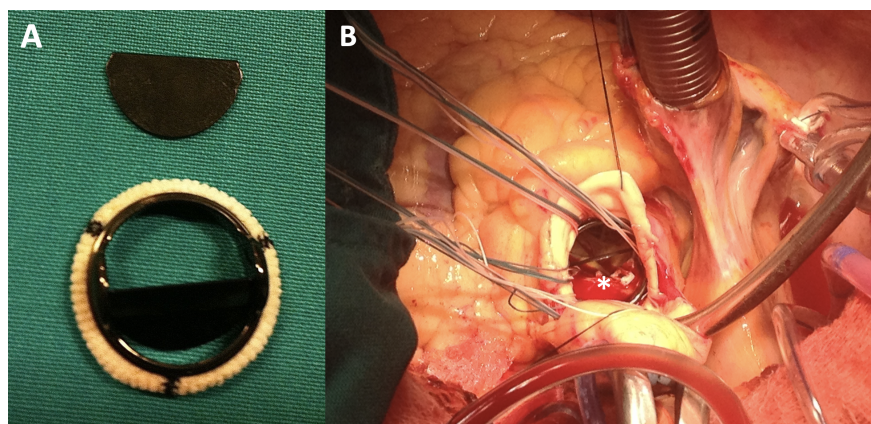
Figure 1

Panel A:

Explanted mechanical valve with retrieved leaflet.

Panel B:

Surgeon's view with the mechanical valve in place, lacking one leaflet (white asterisk).

A 68-year-old patient having severe aortic valve stenosis was scheduled for valve replacement. Intraoperatively, a 19 mm St. Jude Regent (St. Jude Medical, Minneapolis, MN, USA) mechanical valve was implanted. During inspection of the valve, one of the leaflets detached from the pivoting system towards the left ventricle (Figure 1B).

The prosthesis was detached and a new 19 mm mechanical valve was implanted. The patient had an uneventful postoperative course. Strangely, meticulous inspection of the explanted prosthesis and leaflet did not reveal fracture of the strut or pivoting system. (Fig 1A).
