Twenty-years' use of expanded polytetrafluoroethylene sheet for an artificial cardiac pacemaker

¹Japanese Red Cross Kochi Hospital

Clinical Images

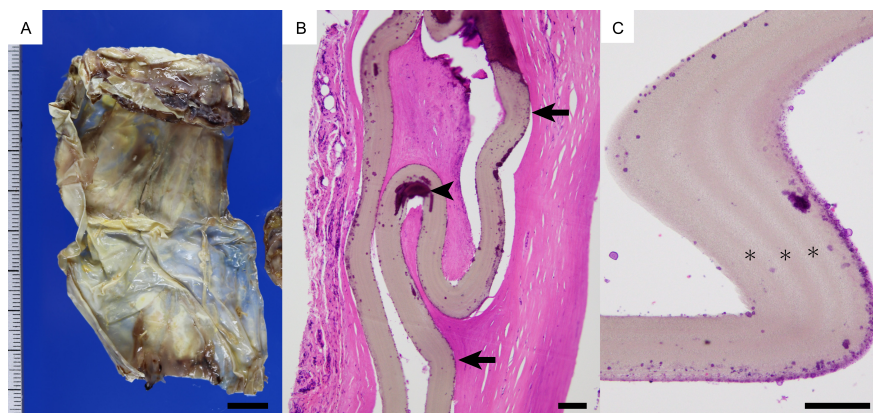
Figure 1

A removed membranous material, which encased the cardiac pacemaker is seen (**A**). Histologically, a foreign body with a thickness of 0.1 mm is embedded in a dense fibrous stroma (**B**). The material and calcification are indicated by arrows and arrowheads, respectively. The higher magnification image of the material shows a laminar structure indicated by asterisks. Scale bar in A, B, and C is 1 cm, 0.1 mm, and 0.1 mm, respectively.

battery had been replaced 11 years ago. The patient had a history of four surgeries for the adjustment of pacemaker lead position. During the second battery replacement, a physician noticed a hard, membranous material encasing the pacemaker. This material was removed (Figure 1A) to reduce the risk of infection. Histological analysis revealed a foreign body, which resembled an expanded polytetrafluoroethylene (ePTFE) sheet with a 0.1 mm-thick laminar structure, embedded in a fibrous stroma (Figure 1B–1C).¹ Although the data concerning the insertion of ePTFE is now unavailable, it is known that ePTFE had been probably used for 20 years. The purpose of the use is unknown; however, ePTFE sheets were likely used for fixation of the pacemaker to avoid pacemaker lead displacement. The sheets also can be used to prevent implant rejection in patients with metal allergies.² Our case likely demonstrates the safety of prolonged use of ePTFE sheets with artificial pacemakers.
